**ASBESTOS SURVEY FOR**

**Galleon Centre**

**99 Titchfield Street,  
Kilmarnock.  
KA1 1QY**

**Surveyed by Carl Ashton**

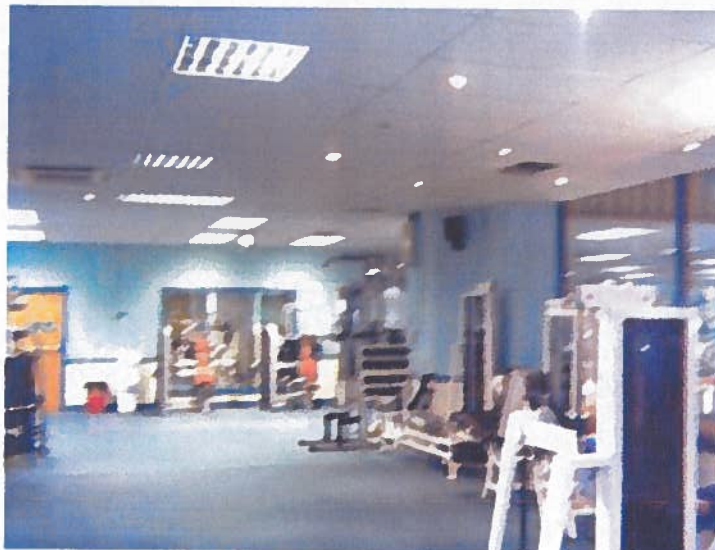
<b><u>SAMPLE REF.</u></b>	22	<b><u>SURVEY TYPE</u></b>	T2
<b><u>DATE TAKEN</u></b>	16/12/04	<b><u>ASBESTOS TYPE</u></b>	No Asbestos Located
<b><u>AREA</u></b>	Main Building	<b><u>ANALYSIS</u></b>	NADIS
<b><u>FLOOR</u></b>	First floor	<b><u>CONDITION</u></b>	NADIS
<b><u>ROOM</u></b>	Fitness Room	<b><u>FRIABILITY</u></b>	NADIS
<b><u>COMPONENT</u></b>	General Construction	<b><u>POSITION</u></b>	NADIS
<b><u>SURVEYOR</u></b>	Carl Ashton	<b><u>TREATMENT</u></b>	NADIS
<b><u>LAB</u></b>		<b><u>MATERIAL RISK</u></b>	0 (NADIS)
<b><u>NEXT INSPECTION</u></b>		<b><u>PRIORITY RISK</u></b>	0 (NFA)
<b><u>REMOVAL COST</u></b>			
<b><u>ACTION</u></b>	No Action Required

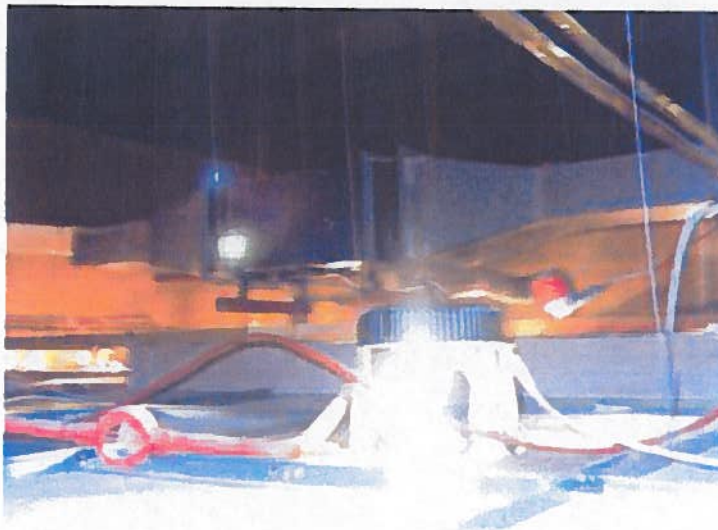
<b><u>SAMPLE REF.</u></b>	23	<b><u>SURVEY TYPE</u></b>	T2
<b><u>DATE TAKEN</u></b>	16/12/04	<b><u>ASBESTOS TYPE</u></b>	No Asbestos Located
<b><u>AREA</u></b>	Main Building	<b><u>ANALYSIS</u></b>	NADIS
<b><u>FLOOR</u></b>	First floor	<b><u>CONDITION</u></b>	NADIS
<b><u>ROOM</u></b>	Male Changing Room	<b><u>FRIABILITY</u></b>	NADIS
<b><u>COMPONENT</u></b>	General Construction	<b><u>POSITION</u></b>	NADIS
<b><u>SURVEYOR</u></b>	Carl Ashton	<b><u>TREATMENT</u></b>	NADIS
<b><u>LAB</u></b>		<b><u>MATERIAL RISK</u></b>	0 (NADIS)
<b><u>NEXT INSPECTION</u></b>		<b><u>PRIORITY RISK</u></b>	0 (NFA)
<b><u>REMOVAL COST</u></b>			
<b><u>ACTION</u></b>	No Action Required

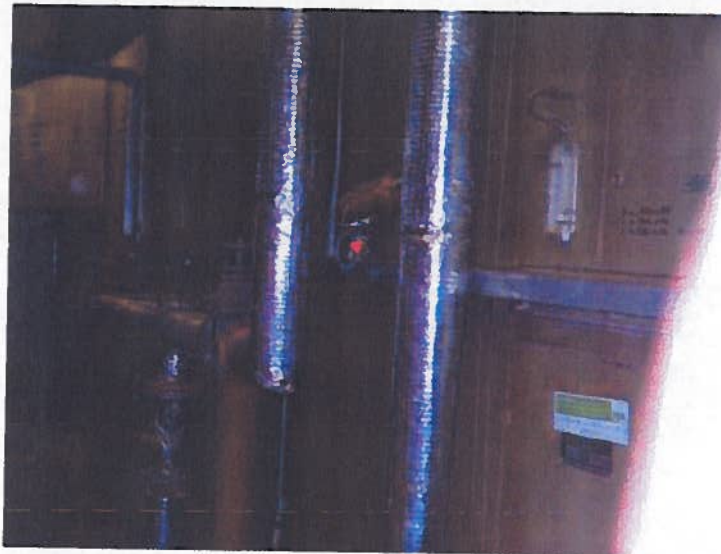
<b><u>SAMPLE REF.</u></b>	24	<b><u>SURVEY TYPE</u></b>	T2
<b><u>DATE TAKEN</u></b>	16/12/04	<b><u>ASBESTOS TYPE</u></b>	No Asbestos Located
<b><u>AREA</u></b>	Main Building	<b><u>ANALYSIS</u></b>	NADIS
<b><u>FLOOR</u></b>	First floor	<b><u>CONDITION</u></b>	NADIS
<b><u>ROOM</u></b>	Plant Room	<b><u>FRIABILITY</u></b>	NADIS
<b><u>COMPONENT</u></b>	General Construction	<b><u>POSITION</u></b>	NADIS
<b><u>SURVEYOR</u></b>	Carl Ashton	<b><u>TREATMENT</u></b>	NADIS
<b><u>LAB</u></b>		<b><u>MATERIAL RISK</u></b>	0 (NADIS)
<b><u>NEXT INSPECTION</u></b>		<b><u>PRIORITY RISK</u></b>	0 (NFA)
<b><u>REMOVAL COST</u></b>			
<b><u>ACTION</u></b>	No Action Required

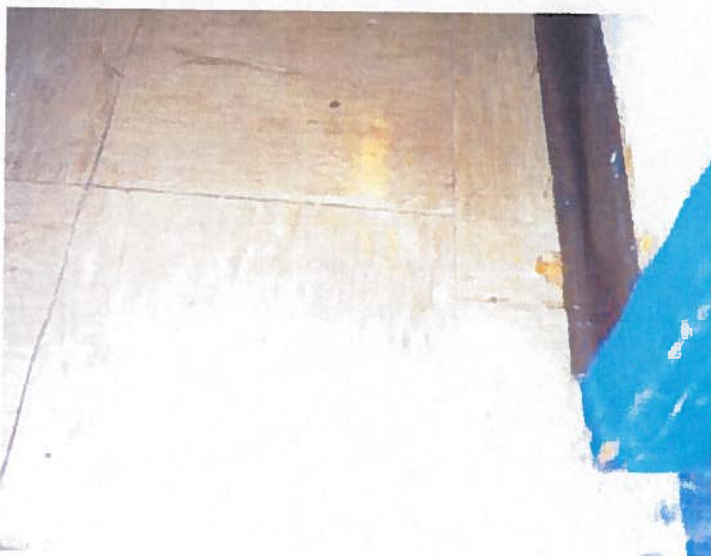
<b><u>SAMPLE REF.</u></b>	25	<b><u>SURVEY TYPE</u></b>	T2
<b><u>DATE TAKEN</u></b>	16/12/04	<b><u>ASBESTOS TYPE</u></b>	NADIS
<b><u>AREA</u></b>	Main Building	<b><u>ANALYSIS</u></b>	NADIS
<b><u>FLOOR</u></b>	First floor	<b><u>CONDITION</u></b>	NADIS
<b><u>ROOM</u></b>	Bonspiel Hallway	<b><u>FRIABILITY</u></b>	NADIS
<b><u>COMPONENT</u></b>	Floor tile	<b><u>POSITION</u></b>	NADIS
<b><u>SURVEYOR</u></b>	Carl Ashton	<b><u>TREATMENT</u></b>	NADIS
<b><u>LAB</u></b>	TVS Analysis Ltd	<b><u>MATERIAL RISK</u></b>	0 (NADIS)
<b><u>NEXT INSPECTION</u></b>		<b><u>PRIORITY RISK</u></b>	0 (NFA)
<b><u>REMOVAL COST</u></b>			
<b><u>ACTION</u></b>	No Action Required

**RECOMMENDATIONS**  
Lab sample no. 03039

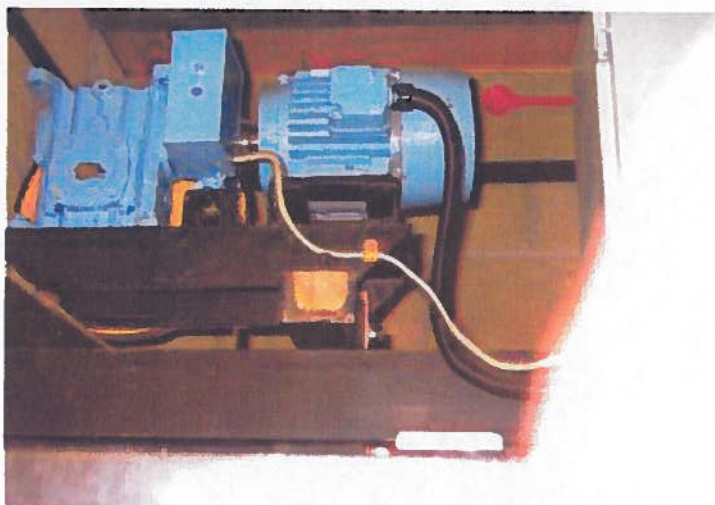
<b><u>SAMPLE REF.</u></b>	27	<b><u>SURVEY TYPE</u></b>	T2
<b><u>DATE TAKEN</u></b>	16/12/04	<b><u>ASBESTOS TYPE</u></b>	No Asbestos Located
<b><u>AREA</u></b>	Main Building	<b><u>ANALYSIS</u></b>	NADIS
<b><u>FLOOR</u></b>	First floor	<b><u>CONDITION</u></b>	NADIS
<b><u>ROOM</u></b>	Service Lift Motor Room	<b><u>FRIABILITY</u></b>	NADIS
<b><u>COMPONENT</u></b>	General Construction	<b><u>POSITION</u></b>	NADIS
<b><u>SURVEYOR</u></b>	Carl Ashton	<b><u>TREATMENT</u></b>	NADIS
<b><u>LAB</u></b>		<b><u>MATERIAL RISK</u></b>	0 (NADIS)
<b><u>NEXT INSPECTION</u></b>		<b><u>PRIORITY RISK</u></b>	0 (NFA)
<b><u>REMOVAL COST</u></b>			
<b><u>ACTION</u></b>	No Action Required

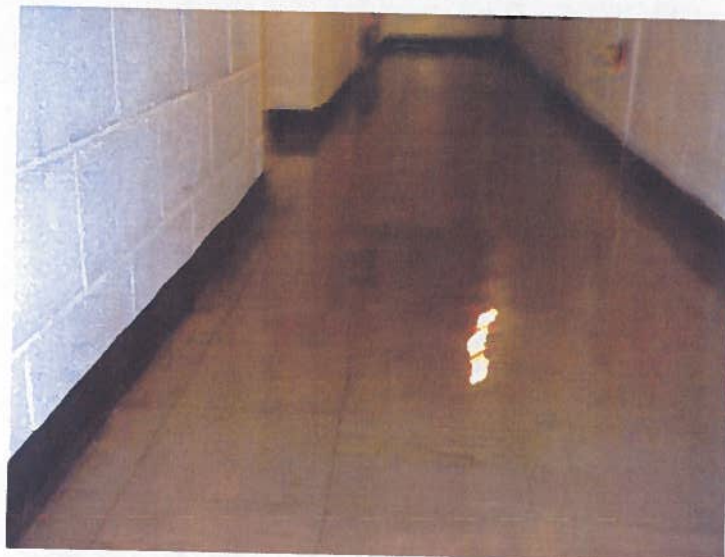
<b><u>SAMPLE REF.</u></b>	28	<b><u>SURVEY TYPE</u></b>	T2
<b><u>DATE TAKEN</u></b>	16/12/04	<b><u>ASBESTOS TYPE</u></b>	NADIS
<b><u>AREA</u></b>	Main Building	<b><u>ANALYSIS</u></b>	NADIS
<b><u>FLOOR</u></b>	First floor	<b><u>CONDITION</u></b>	NADIS
<b><u>ROOM</u></b>	Squash Court Viewing Area	<b><u>FRIABILITY</u></b>	NADIS
<b><u>COMPONENT</u></b>	Floor tile	<b><u>POSITION</u></b>	NADIS
<b><u>SURVEYOR</u></b>	Carl Ashton	<b><u>TREATMENT</u></b>	NADIS
<b><u>LAB</u></b>	TVS Analysis Ltd	<b><u>MATERIAL RISK</u></b>	0 (NADIS)
<b><u>NEXT INSPECTION</u></b>		<b><u>PRIORITY RISK</u></b>	0 (NFA)
<b><u>REMOVAL COST</u></b>			
<b><u>ACTION</u></b>	No Action Required

**RECOMMENDATIONS**  
Lab sample no. 03041

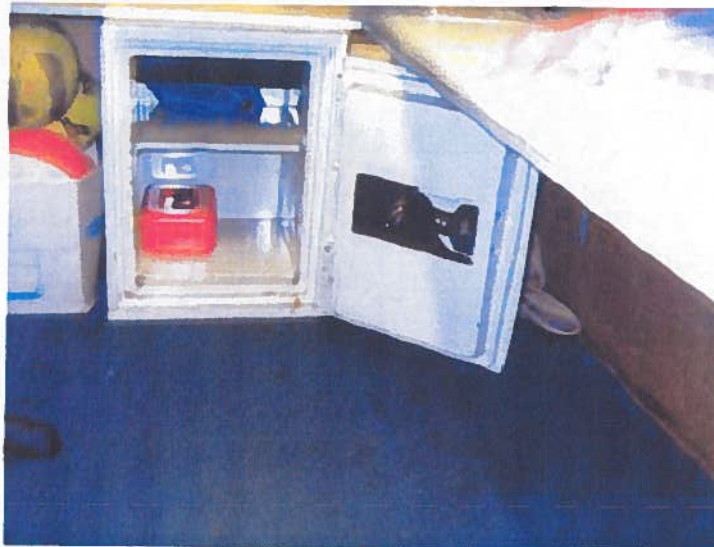
<b><u>SAMPLE REF.</u></b>	29	<b><u>SURVEY TYPE</u></b>	T2
<b><u>DATE TAKEN</u></b>	16/12/04	<b><u>ASBESTOS TYPE</u></b>	Amosite/Chrysotile/Crocidolite
<b><u>AREA</u></b>	Main Building	<b><u>ANALYSIS</u></b>	Assumed Medium
<b><u>FLOOR</u></b>	Ground floor	<b><u>CONDITION</u></b>	Good
<b><u>ROOM</u></b>	Reception Office	<b><u>FRIABILITY</u></b>	Low
<b><u>COMPONENT</u></b>	Safe	<b><u>POSITION</u></b>	Internal
<b><u>SURVEYOR</u></b>	Carl Ashton	<b><u>TREATMENT</u></b>	Sealed
<b><u>LAB</u></b>		<b><u>MATERIAL RISK</u></b>	6 (Very Low)
<b><u>NEXT INSPECTION</u></b>	20/12/05	<b><u>PRIORITY RISK</u></b>	0 (NFA)
<b><u>REMOVAL COST</u></b>			
<b><u>ACTION</u></b>	Refer to Manufacturer

**RECOMMENDATIONS**  
 Some older units had materials within, that contained asbestos.  
 Safe also located to the Managers Office.

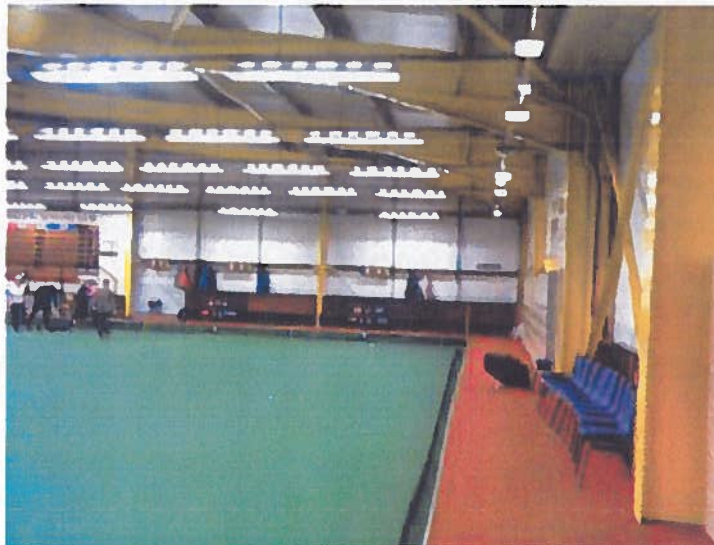
<b><u>SAMPLE REF.</u></b>	30	<b><u>SURVEY TYPE</u></b>	T2
<b><u>DATE TAKEN</u></b>	16/12/04	<b><u>ASBESTOS TYPE</u></b>	No Asbestos Located
<b><u>AREA</u></b>	Main Building	<b><u>ANALYSIS</u></b>	NADIS
<b><u>FLOOR</u></b>	Ground floor	<b><u>CONDITION</u></b>	NADIS
<b><u>ROOM</u></b>	Bowling Area	<b><u>FRIABILITY</u></b>	NADIS
<b><u>COMPONENT</u></b>	General Construction	<b><u>POSITION</u></b>	NADIS
<b><u>SURVEYOR</u></b>	Carl Ashton	<b><u>TREATMENT</u></b>	NADIS
<b><u>LAB</u></b>		<b><u>MATERIAL RISK</u></b>	0 (NADIS)
<b><u>NEXT INSPECTION</u></b>		<b><u>PRIORITY RISK</u></b>	0 (NFA)
<b><u>REMOVAL COST</u></b>			
<b><u>ACTION</u></b>	No Action Required

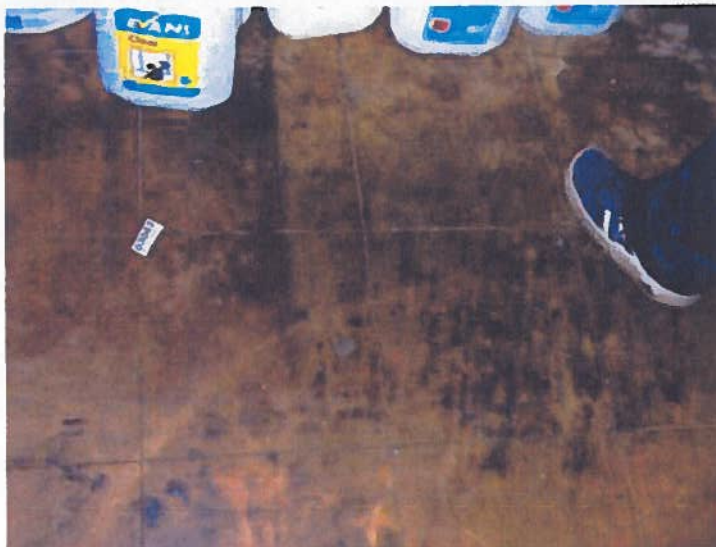
<b><u>SAMPLE REF.</u></b>	35	<b><u>SURVEY TYPE</u></b>	T2
<b><u>DATE TAKEN</u></b>	16/12/04	<b><u>ASBESTOS TYPE</u></b>	NADIS
<b><u>AREA</u></b>	Main Building	<b><u>ANALYSIS</u></b>	NADIS
<b><u>FLOOR</u></b>	Ground floor	<b><u>CONDITION</u></b>	NADIS
<b><u>ROOM</u></b>	Cleaning Store	<b><u>FRIABILITY</u></b>	NADIS
<b><u>COMPONENT</u></b>	Floor tile	<b><u>POSITION</u></b>	NADIS
<b><u>SURVEYOR</u></b>	Carl Ashton	<b><u>TREATMENT</u></b>	NADIS
<b><u>LAB</u></b>	TVS Analysis Ltd	<b><u>MATERIAL RISK</u></b>	0 (NADIS)
<b><u>NEXT INSPECTION</u></b>		<b><u>PRIORITY RISK</u></b>	0 (NFA)
<b><u>REMOVAL COST</u></b>			
<b><u>ACTION</u></b>	No Action Required

**RECOMMENDATIONS**  
Lab sample no. 03043

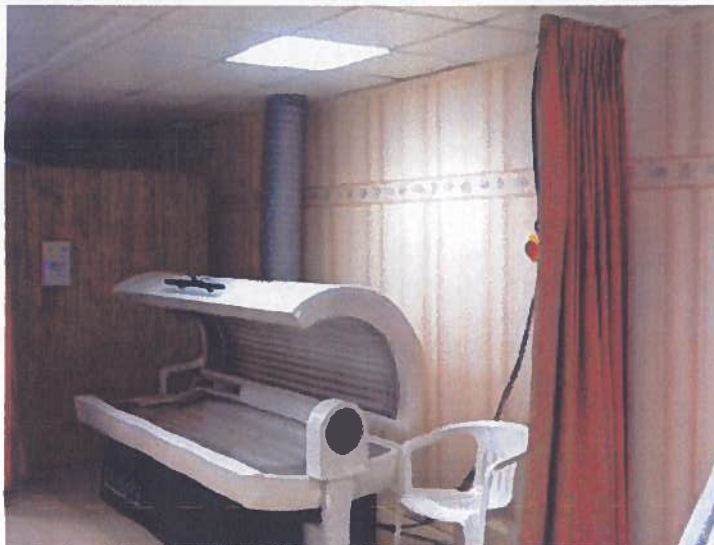
<b><u>SAMPLE REF.</u></b>	36	<b><u>SURVEY TYPE</u></b>	T2
<b><u>DATE TAKEN</u></b>	16/12/04	<b><u>ASBESTOS TYPE</u></b>	No Asbestos Located
<b><u>AREA</u></b>	Main Building	<b><u>ANALYSIS</u></b>	NADIS
<b><u>FLOOR</u></b>	Ground floor	<b><u>CONDITION</u></b>	NADIS
<b><u>ROOM</u></b>	Sauna	<b><u>FRIABILITY</u></b>	NADIS
<b><u>COMPONENT</u></b>	General Construction	<b><u>POSITION</u></b>	NADIS
<b><u>SURVEYOR</u></b>	Carl Ashton	<b><u>TREATMENT</u></b>	NADIS
<b><u>LAB</u></b>		<b><u>MATERIAL RISK</u></b>	0 (NADIS)
<b><u>NEXT INSPECTION</u></b>		<b><u>PRIORITY RISK</u></b>	0 (NFA)
<b><u>REMOVAL COST</u></b>			
<b><u>ACTION</u></b>	No Action Required

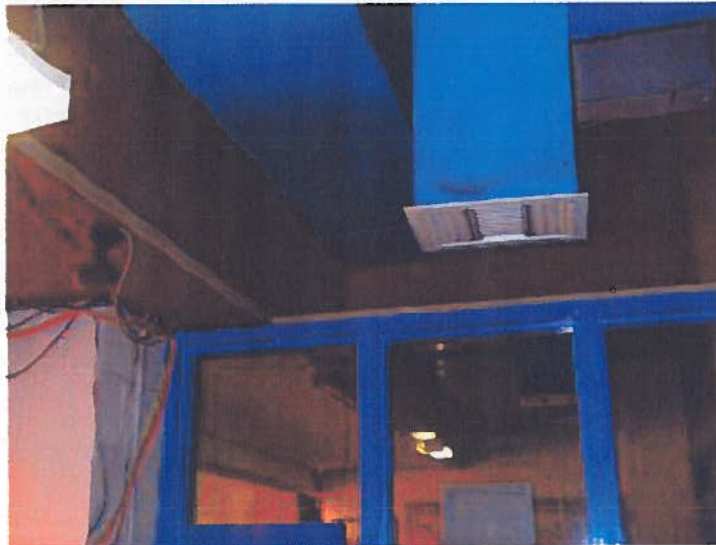
<b><u>SAMPLE REF.</u></b>	37	<b><u>SURVEY TYPE</u></b>	T2
<b><u>DATE TAKEN</u></b>	16/12/04	<b><u>ASBESTOS TYPE</u></b>	No Asbestos Located
<b><u>AREA</u></b>	Main Building	<b><u>ANALYSIS</u></b>	NADIS
<b><u>FLOOR</u></b>	Ground floor	<b><u>CONDITION</u></b>	NADIS
<b><u>ROOM</u></b>	Ice Rink Office	<b><u>FRIABILITY</u></b>	NADIS
<b><u>COMPONENT</u></b>	General Construction	<b><u>POSITION</u></b>	NADIS
<b><u>SURVEYOR</u></b>	Carl Ashton	<b><u>TREATMENT</u></b>	NADIS
<b><u>LAB</u></b>		<b><u>MATERIAL RISK</u></b>	0 (NADIS)
<b><u>NEXT INSPECTION</u></b>		<b><u>PRIORITY RISK</u></b>	0 (NFA)
<b><u>REMOVAL COST</u></b>			
<b><u>ACTION</u></b>	No Action Required

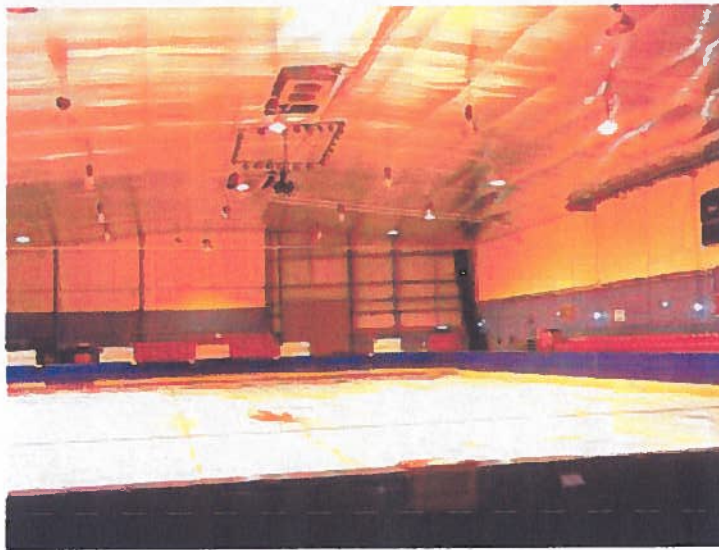
<b><u>SAMPLE REF.</u></b>	38	<b><u>SURVEY TYPE</u></b>	T2
<b><u>DATE TAKEN</u></b>	16/12/04	<b><u>ASBESTOS TYPE</u></b>	No Asbestos Located
<b><u>AREA</u></b>	Main Building	<b><u>ANALYSIS</u></b>	NADIS
<b><u>FLOOR</u></b>	Ground floor	<b><u>CONDITION</u></b>	NADIS
<b><u>ROOM</u></b>	Ice Rink Hall	<b><u>FRIABILITY</u></b>	NADIS
<b><u>COMPONENT</u></b>	General Construction	<b><u>POSITION</u></b>	NADIS
<b><u>SURVEYOR</u></b>	Carl Ashton	<b><u>TREATMENT</u></b>	NADIS
<b><u>LAB</u></b>		<b><u>MATERIAL RISK</u></b>	0 (NADIS)
<b><u>NEXT INSPECTION</u></b>		<b><u>PRIORITY RISK</u></b>	0 (NFA)
<b><u>REMOVAL COST</u></b>			
<b><u>ACTION</u></b>	No Action Required

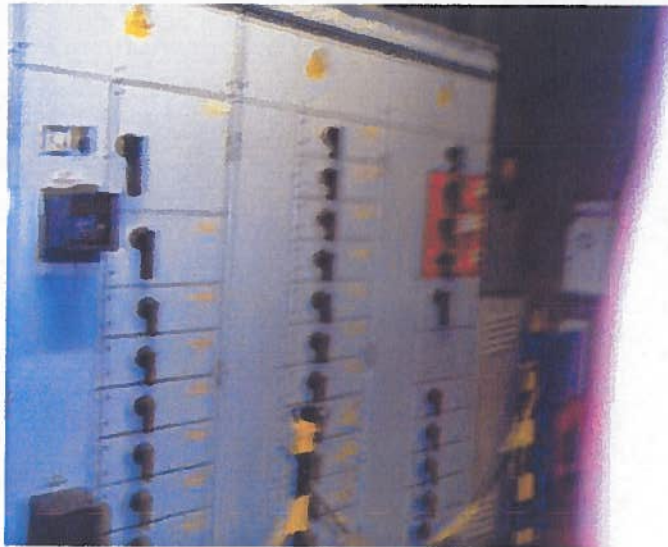
<b><u>SAMPLE REF.</u></b>	40	<b><u>SURVEY TYPE</u></b>	T2
<b><u>DATE TAKEN</u></b>	16/12/04	<b><u>ASBESTOS TYPE</u></b>	Amosite/Chrysotile/Crocidolite
<b><u>AREA</u></b>	Main Building	<b><u>ANALYSIS</u></b>	Assumed Low
<b><u>FLOOR</u></b>	Ground floor	<b><u>CONDITION</u></b>	Good
<b><u>ROOM</u></b>	Games Room Store	<b><u>FRIABILITY</u></b>	Low
<b><u>COMPONENT</u></b>	Electrical Panel	<b><u>POSITION</u></b>	Internal
<b><u>SURVEYOR</u></b>	Carl Ashton	<b><u>TREATMENT</u></b>	None
<b><u>LAB</u></b>		<b><u>MATERIAL RISK</u></b>	5 (Very Low)
<b><u>NEXT INSPECTION</u></b>	20/12/05	<b><u>PRIORITY RISK</u></b>	0 (NFA)
<b><u>REMOVAL COST</u></b>			
<b><u>ACTION</u></b>	Refer to Manufacturer

Some older panels had woven flash pads within that sometimes contained asbestos.
